This TSB applies to 2009 Audi TT, A3 and A4 models, equipped with the 2.0L TFSI engine. Timing chain noise may be heard, accompanied by DTC P001600.

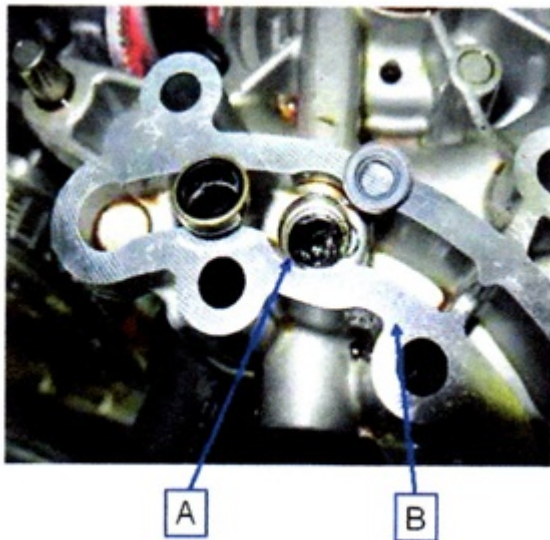
The check valve ball in the camshaft positioner bridge may become dislodged. Fragments of the screen and the ball can restrict oil flow to the bearing bridge. Particles of the screen can also reach the camshafts and damage the bearing surfaces.

The check valve (A) and bearing bridge (B) of the camshaft positioner bridge

If the screen and check valve are not damaged, replace the camshaft and bridge, and erase the DTC.

If the screen or check valve are damaged, inspect the bearing surfaces of the camshafts for scoring marks, and replace any camshaft or cylinder head that exhibits camshaft bearing damage.

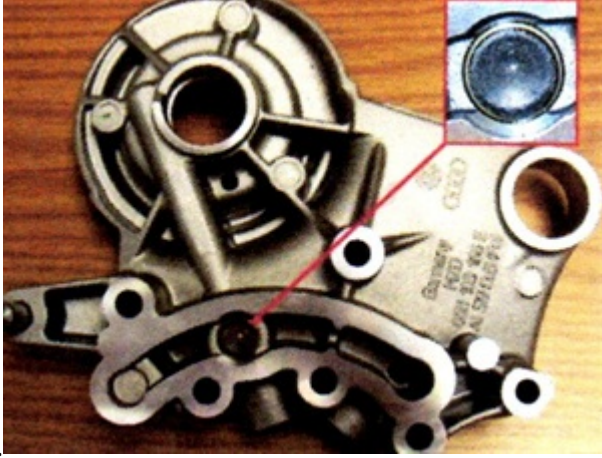
Camshaft bridge with screen and check valve in place
