# Technical Service Bulletin

## MIL on (DTC P310B and/or P129F)

24 07 19 2015106/3 Nov. 19, 2007. Supersedes Technical Service Bulletin Group 24 number 07-08 dated June 19, 2007 to update parts numbers.

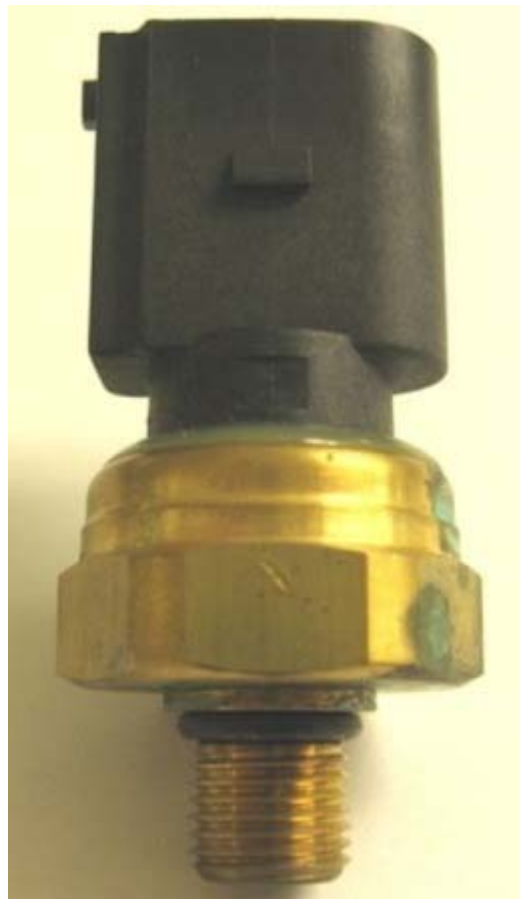
Due to fuel intrusion into the low pressure side fuel pressure sensor (G410), a false signal may be sent to the controller resulting in a reading that is out of tolerance. The false signal results in the setting of **DTC P310B** or **DTC P129F** and illumination of the malfunction indicator lamp.

**Figure 2.** Fuel pressure sensor 06E 906 051 J.

1. Replace the G410 low-side fuel pressure sensor.

2. Clear DTCs and verify that the problem was eliminated.

3. Run Basic Settings 103 to adapt system.
4. Do not replace fuel pump, fuel pump control module or fuel filter unless problem persists.
