# THE MISSING LINK

In this article we investigate an example fitted to a BMW E61 520d, that had covered 180,000km and had an engine that suddenly stopped, due to a suspected timing chain failure.

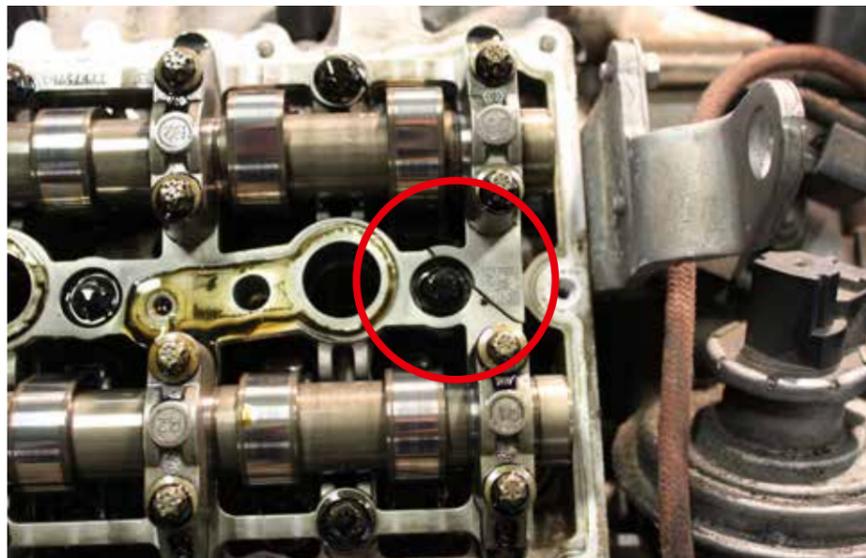
Fig. 1

With the engine removed, the rocker cover was taken off to view any damage. The camshaft chain was not visible and after inspection it was located at the bottom of the timing chain housing and also five rocker arms were broken.

The camshaft support had sustained a significant fracture, which shows that a significant torsional force has been absorbed by the engine timing components. (Fig 1)

The cylinder head was prepared for reassembly with a new camshaft support, camshaft and new rocker arms (febi 30132). Note: the tightening of the bracket bolts must not exceed 20Nm and it is important to ensure that the camshaft bearings are lubricated before installation. The cylinder head was then reassembled and fitted to the engine block, using new bolts (febi 39805).

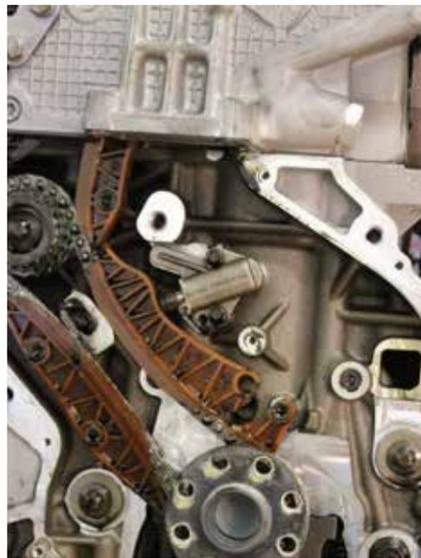
Fig. 2

After the removal of the timing chain housing, further damage was revealed. The upper chain had one broken link, the high-pressure fuel pump sprocket had broken teeth and the chain guide was also broken. (Fig 2)

This is a typical example of a chain failure on the N47 engine.

When replacing a timing chain it is vital that all the components of the timing chain are replaced without any exception, failure to replace certain components can lead to serious consequences in engine operation.

The febi timing chain kit 102040 for this engine has all the necessary parts for the repair. The kit includes upper and lower chains, chain guides, tensioners and sprockets for the fuel injection pump and camshafts and also the oil nozzle for the lower chain.

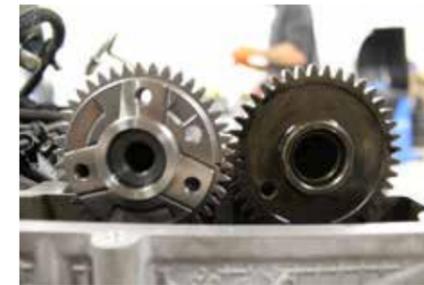
Fig. 3

Then the timing of the camshafts and crankshaft was checked, this is essential for correct engine operation. The camshaft pinions have timing marks, which must be placed opposite each other parallel to the cylinder head. (Fig 3) The crankshaft is fixed by means of a pin in the flywheel, which is removed, we recommend that it be temporarily reassembled to check the locking.

With all chains in place and the flywheel locked in position, the alignment was checked of the AAC markings on the cylinder head. As everything was correct, the camshaft sprocket was tightened with the three retaining bolts. If the alignment is not correct it can be corrected by turning the exhaust camshaft with a 32 mm spanner. Then check the fuel injection pump sprocket for the correct tightness.

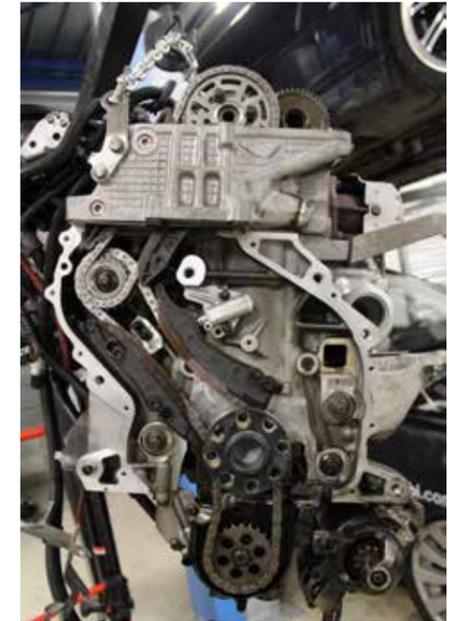
Fig. 4

The assembly of the febi 102040 timing chain kit was complete, the engine was turned over by hand for several revolutions to check that the engine was turning freely. (Fig 4)
