Dual-mass flywheels decrease noise and improve refinement on the move.

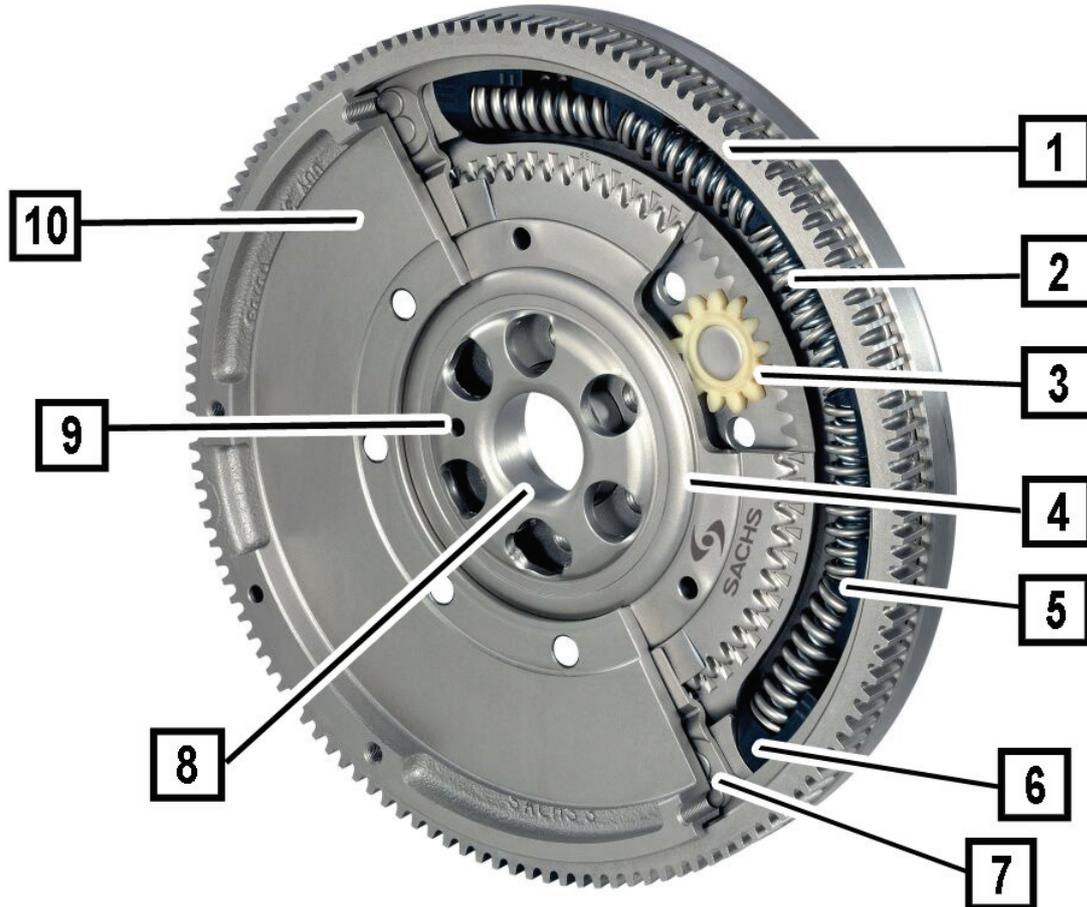
1) Primary flywheel; 2) Springs; 3) Planetary gear; 4) Plain bearing, axial; 5) Sliding shoe; 6) Spring cap; 7) Cover plate to retain grease content; 8) Plain bearing, radial; 9) Hole for securing pin; 10) Secondary flywheel

- Clean the dual-mass flywheel with oil- and grease-free rags only. High-pressure cleaners, steam jets, cleaning sprays or compressed air must not be used. That could lead to dirt or cleaning agents getting inside the dual-mass flywheel and causing increased wear.

- For technical reasons, the secondary flywheel (10) friction area must not be reworked!
- The primary (1) and secondary flywheel (10) have to be prevented from rotating with a 6mm-pin (9) before removing it from the crankshaft. If this is omitted, the secondary flywheel could be damaged by a bolt head.

When installed, the primary and secondary flywheels can be rotated against each other by hand. Measured on the external diameter of the dual-mass flywheel, the rotation of the secondary flywheel amounts to 10 mms clockwise and 10 mms counter-clockwise. Rotation tolerance must be equal in both directions. In any case, the secondary flywheel has to turn back to its original position by itself.

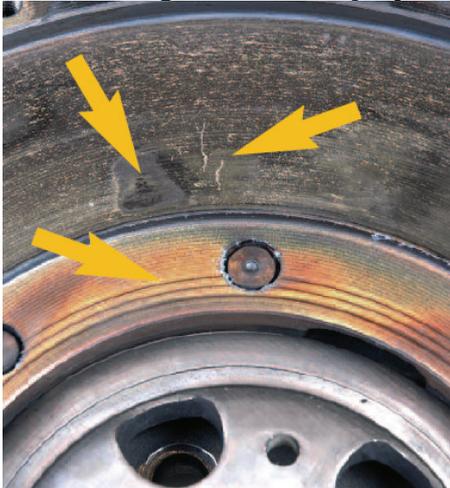
#### Overheating of secondary flywheel

Caused by incorrect clutch use, e.g. clutch slip.

- Heat counteracts the effect of the damping grease. Sliding shoes, spring caps and springs run dry.
- Vibration damping performance is reduced or fails.
- Heat spots can cause clutch grabbing.

Clearly visible annealing discoloration and heat cracking.

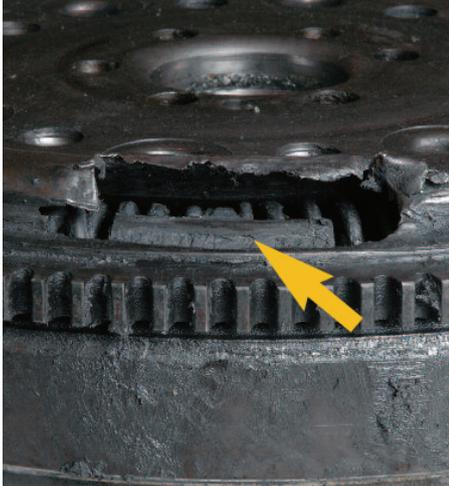
### Primary flywheel worn through

Extreme mechanical strain on entire DMF. This may be due to a rough running engine, e.g. caused by faulty injectors.

- Destruction of interior components
- In extreme cases, internal components wear through the housing of the primary flywheel. This leads to total failure of the DMF.

Lubricant leakage is another sign of this problem.

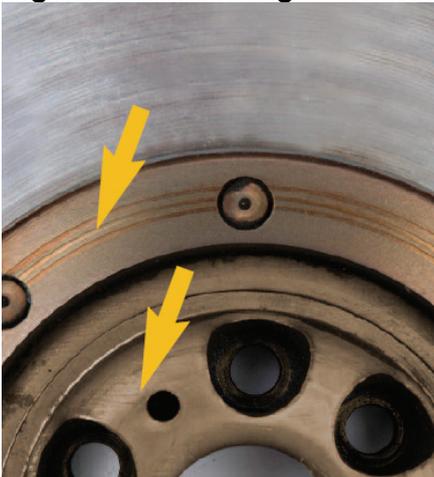
### Signs of overheating inside on the secondary flywheel

Thrust bearing wear between primary and secondary flywheel due to mechanical strain.

Heat counteracts the effect of the damping grease. Sliding shoes, spring caps and springs run dry.

Clearly noticeable by the temper colors, as well as the unusual vehicle noise that gets stronger when disengaging the clutch.

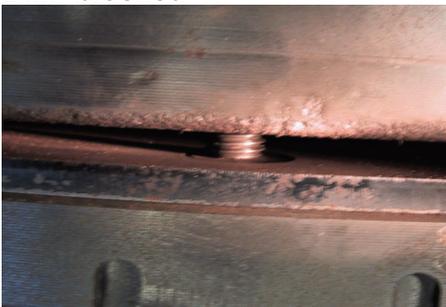
### DMF blocked

Excessively long screws used to fit the cover assembly can block the primary and secondary flywheels.

- Vibrations cannot be dampened
- Noise levels cannot be reduced
